Readiness Office

23 December 2015

SUBJECT: Technical Assistance Report concerning post-wildfire potential in Clearwater and Idaho Counties, Idaho

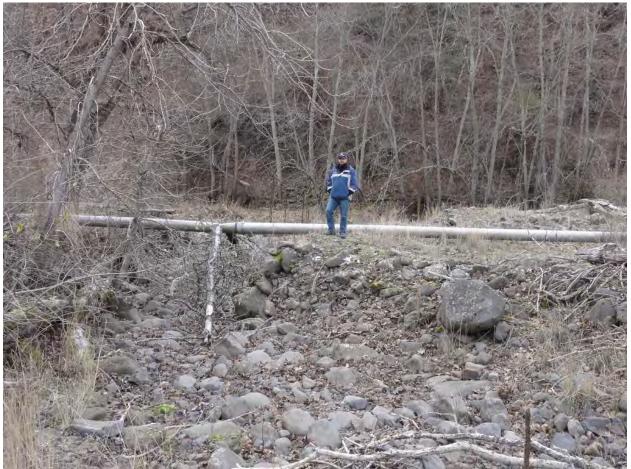
Photo 1. Restricted Suzie Creek channel near confluence. The water pipe and downed tree have the potential to catch debris and exacerbate the constriction at the mouth of Suzie Creek.

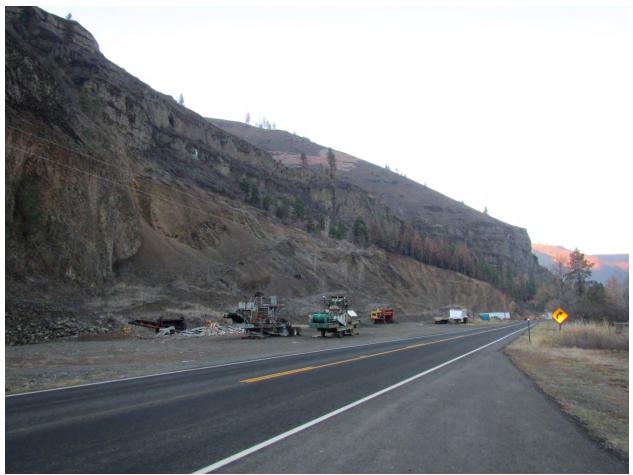
On Sevenmile Creek, which is a tributary to Lawyer Creek, the burned area consists of only the downstream most 1.5 miles on the left bank of the creek. This is a relatively small affected area compared to some of the other burned areas observed. However, this 1.5 mile portion of the drainage contains State Hwy. 162, a primary route from Kamiah to the Prairie. The topography on the burned side of the canyon consists primarily of a near-vertical basalt cliff on the lower half of the canyon side, with the upper half of the canyon side having a moderate slope and shallow overburden. Landslide risk is moderate for the area at and below the basalt cliff, but given the rocky nature of the materials and relatively minimal amounts of sediment, the likelihood of a problematic slide is low. Most of the losse and slide prone material is talus at the base of the cliff. Photo 2 below shows the burned area along State Highway 162.

Photo 2. State Hwy 162 along the burned area in Sevenmile Creek.

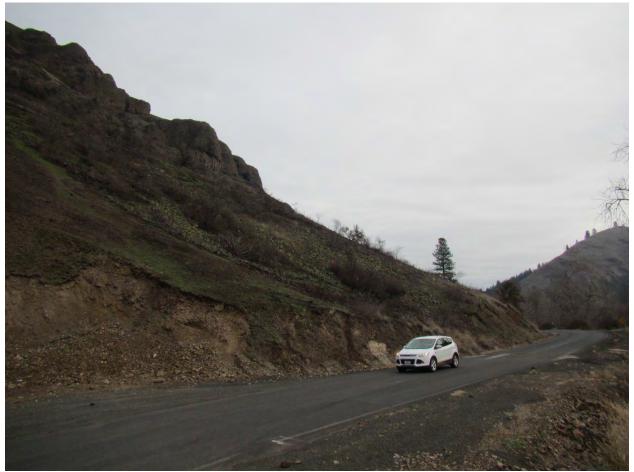
Landslide risk on the main stem of Lawyer Creek is greatest and most concentrated on the left bank side of the canyon, particularly upstream of the State Highway 162 bridge. In this area, the canyon slope consists of a steep basalt cliff at mid-slope, with an accumulation of talus below it and moderately steep bare slopes above it. Lawyer Creek Road, which provides access to some residences and the Flying B Ranch, is located at the base of the slope. Lawyer Creek Road cuts into the talus which has initiated minor rockslides in the past. These slides will likely be more frequent and possibly larger in scale. Given the wide valley, these slides are not likely to impact flooding; however, they may temporarily cut off access along Lawyer Creek Road (see Photo 3 below). Conditions similar to those on Lawyer Creek Road are found on

Photo 3. Slide prone area along Lawyer Creek Road.

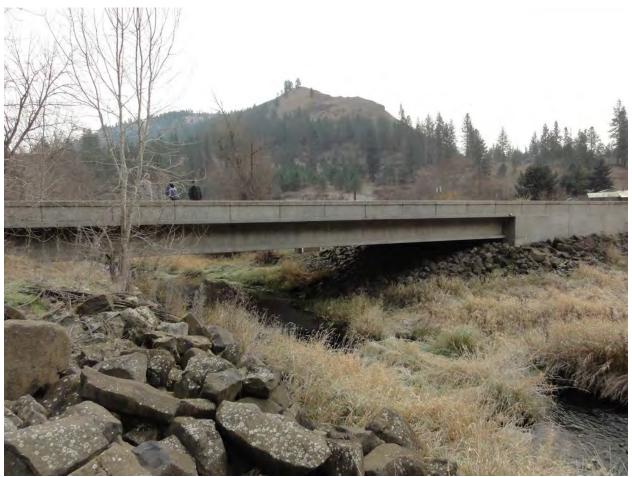
The Nichols Rd Bridge and Highway 162 Bridge both appear to have sufficient capacity to pass higher flows, and the latter of these two lacks piers that tend to capture floating debris. The bridge upstream of Highway 162 (Robison Bridge?) may experience capacity issues and be flanked at moderate flows (*i.e.*, at probabilities greater than 10 percent). County officials also noted capacity problems at culverts along Sevenmile Rd, but they already had plans to address these.

Photo 4. Current Highway 162 Bridge over Lawyer Creek.

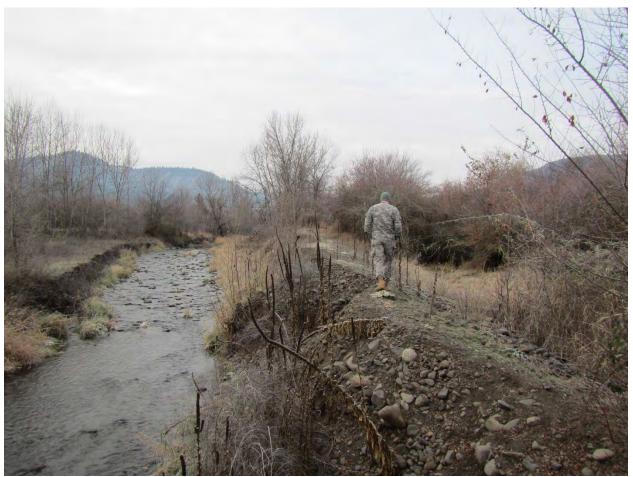
The levees along Lawyer Creek had an authorized capacity of 5,500 CFS, equivalent to approximately a 50 year flood event with 2 feet of freeboard. The levee was rated "unacceptable" in the 2010 Periodic Inspection and has not been rated since. The report documenting the 2010 Unacceptable rating noted significant erosion/ bank caving, seepage, and slope stability problems along the length of the levees, where they were still present. Field observations during the Advance Measures mission confirmed that the levee was still in this condition.

Photo 5. Eroded left bank levee upstream of the railroad bridge in Kamiah.

- Recommendation 2-1. Clean the borrow ditch at the base of the hill along Lawyer Creek Road.
- Recommendation 2-2. Repair the left bank levee upstream of the railroad bridge. The left bank levee has been almost entirely eroded and is in danger of completely failing for a 300 foot segment immediately upstream of the railroad bridge. See Photo 5.

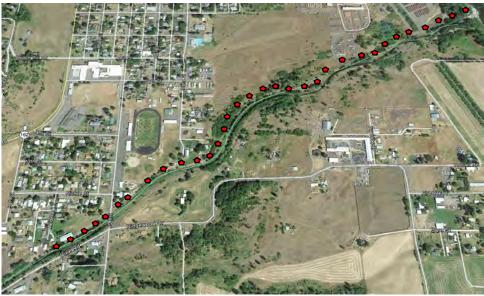
- The Railroad Bridge has historically been a flow constriction on Lawyer Creek, pushing excess flows out of bank and flooding parts of Kamiah. Given the increased likelihood of higher discharges, coupled with higher sediment and debris loads, this bridge constriction represents a good candidate for pro-active confinement, such as by raising (or adding, where no longer present) levee(s) (matches Dan's 2-1 Recommendation point). As also noted elsewhere, extensive bank erosion has occurred in this vicinity in the past, and it would be prudent to reinforce such areas.

Figure 2. Potential temporary setback levee extents to protect the City of Kamiah, Idaho against increased flood potential.

- Recommendation 2-3. Proactively repairing existing levees or building temporary levees or temporary setback levees. Temporary levees potentially could be built under Advance Measures authority, under direct assistance, if an imminent threat of unusual flooding is recognized with sufficient lead time (generally 30 days) to seek funding, and mobilize construction work. Repair of the levee rated as "unacceptable" in the 2010 Periodic Inspection Report is not feasible under Advance Measures. Idaho County and the District Readiness Office should discuss this topic directly. A non-federal effort could be undertaken proactively for the repairs or construction of temporary levees. Temporary levees could include:

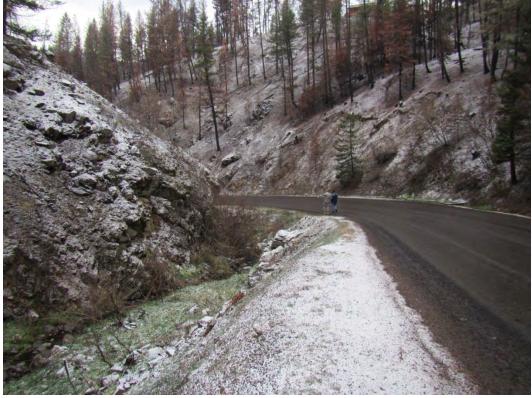
quarry operated by Clearwater Rock Products, there is debris in the channel and evidence of past slides, both of which have the potential to push the stream out into the road (see Photo 6). At another location (downstream of the quarry where the stream takes a gradual leftturn) rock outcrop and the road constrict the channel to a narrow chute that could easily plug with debris. If a debris dam formed here flooding on the road would be very likely.

Photo 6. Upstream of the Adams Grade/Glenwood Road intersection. Potential flooding of the road is possible at this location where the channel could easily plug.

- Recommendation 3-3. The culverted crossing to a gravel mine may be undersized for post-fire peak runoff magnitudes. It may be prudent to replace this with a larger-diameter culvert.
- Recommendation 3-4. Generally monitor the area upstream of the Adams Grade/Glenwood Road intersection, on Glenwood Road. The primary concern is flooding of the road. If a debris dam formed here flooding on the road would be very likely.
- Clean the borrow ditch along Glenwood Road.

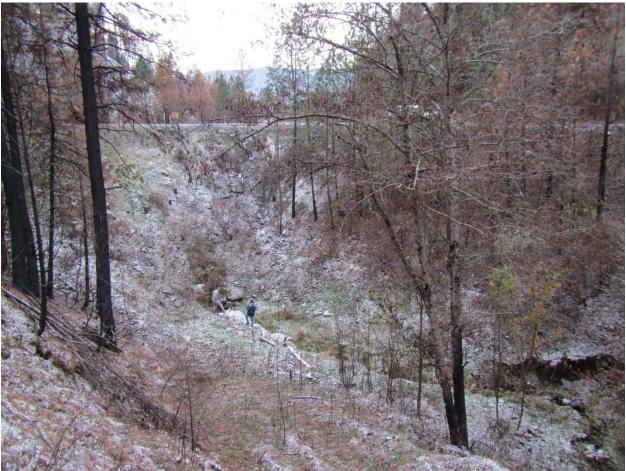
On the Adams Grade road there are no specific locations of concerns relative to slides. At the downstream end of the road there is a large embankment, approximately 50 feet tall, made by Glenwood Road (see Photo 7). A culvert runs through this the embankment. If this culvert were to plug, it would be difficult to remove the debris due to the inability of equipment to reach the culvert from the roadway, and access from within the channel itself would be inundated. This culvert and embankment is a potentially problematic location.

Photo 7. Culvert and embankment at the intersection of Adams Grade and Glenwood Road.

• Recommendation 3-2. The right-bank tributary drainage that enters Tom Taha Creek at the intersection of Adam's Grade and Glenwood Road raises significant concern. At this location, a four feet diameter culvert passes underneath some 40-50 feet of roadway

embankment. The tributary appears to drain a substantial area of steeply sloped watershed within the burned perimeter. Even without post-fire runoff, it appears that this culvert may be undersized for the magnitudes of flow that this area could generate. Additionally, it is anticipated that it would be extremely difficult to reach the culvert entrance with mechanized equipment, due to the high, steep embankment and canyon walls, making clearing all but impossible should it become clogged with debris. It is recommended that, at a minimum, a trash rack be installed to reduce the potential for clogging the upstream end of this culvert, and that consideration be given to adding an additional culvert to pass additional flow at this location. It may be possible to bore and jack a pipe through the embankment, to preclude the need to excavate the large amount of material. A clogged culvert may not back water up sufficiently to reach homes, but could cause significant damage to the road embankment.

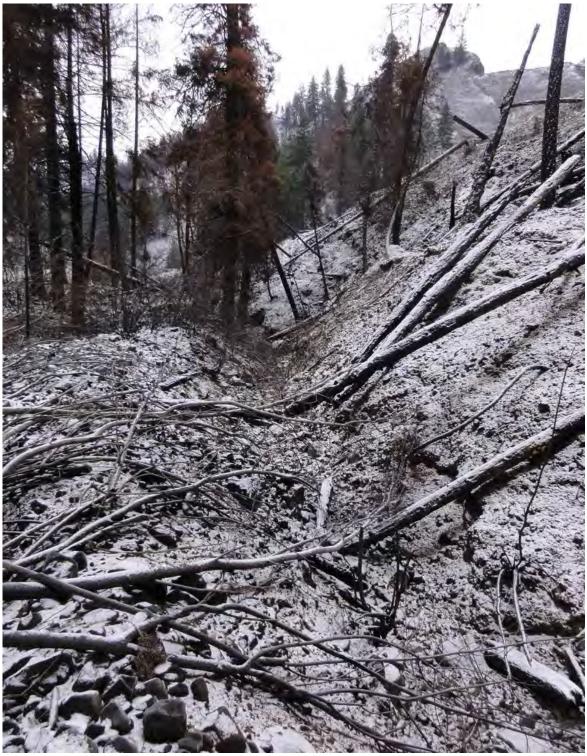
Photo 8. Reach of apparently inadequate channel capacity, Tom Taha Creek adjacent to Glenwood Rd.

• Recommendation 3-1. A reach of pronounced low-capacity channel was observed adjacent to Glenwood Rd (see Photo 8), where a material has apparently been added to confine flows. The berm is located directly alongside the minimal V-channel, though there is room to place a levee *set-back* some distance from the channel right bank. It is recommended that set-back berms be used where possible along this confined reach, to both add additional conveyance area as well as to better attenuate peak flows. Also, cleaning the creek channel on the slope below the Clearwater Rock Products quarry may improve conveyance.

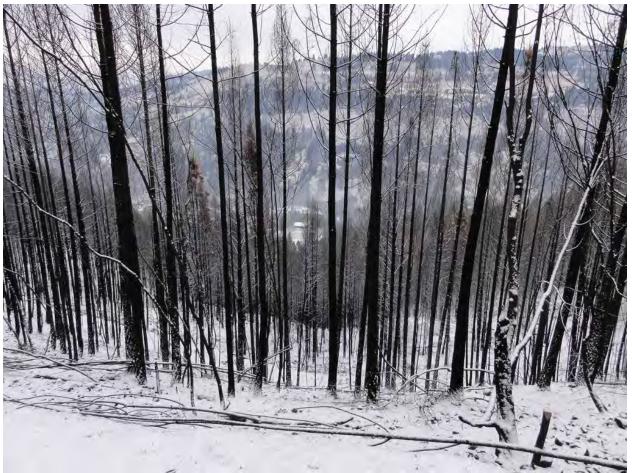
Photo 9. Downslope view from burned area towards Orofino (structures visible beyond intact conifers).

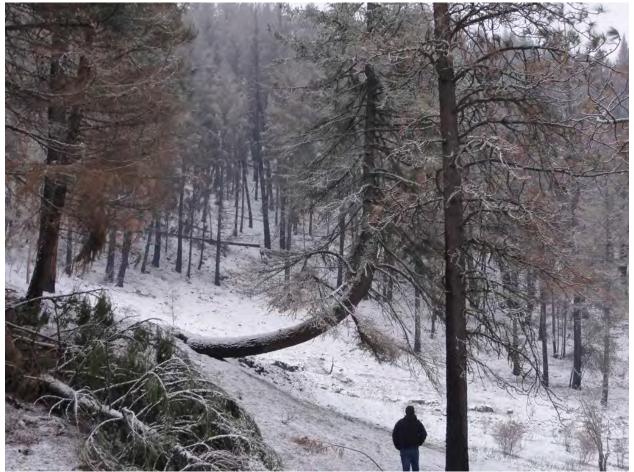
(b) Sediment and Debris. Field conditions along the north-facing slopes adjoining Orofino Creek suggest that mass wasting slope failures can occur (see Photo 10), even without the impacts of wildfire. The changes in soil conditions following the fire, along with the loss of vegetation make such failures more probable. Such slope failures could introduce significant sediment, trees, and rocky debris into Orofino Creek.

Photo 10. Tree deformation upslope from Orofino, may be indicative of past slope failure.

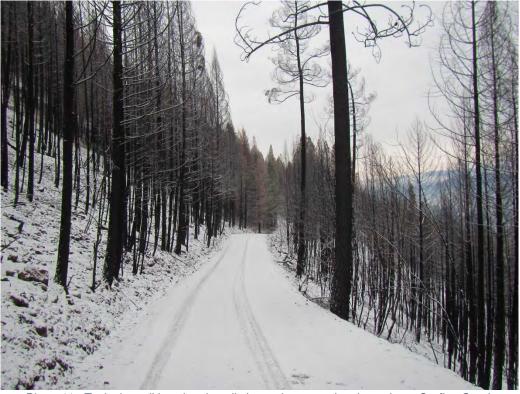
Photo 11. Typical conditions in a heavily burned area on the slope above Orofino Creek.

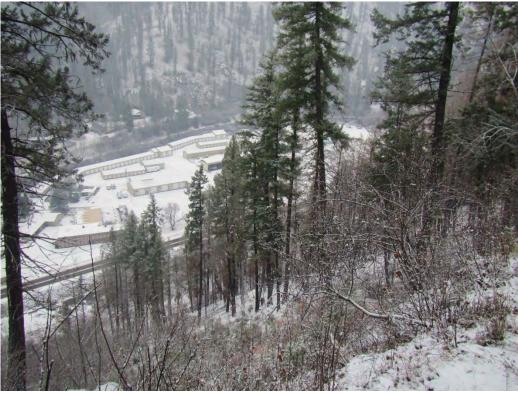
Photo 12. Typical conditions on the slope above Orofino Creek.

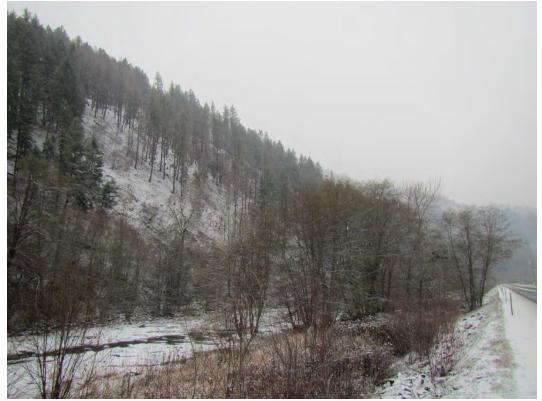
Photo 13. View of the steep slope, Orofino Creek, and the road.

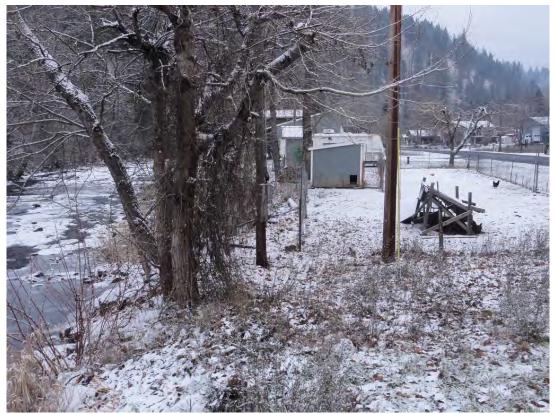
Photo 14. Flood prone structures along Orofino Creek.

- (b) Site Specific. Site specific recommendations are called out on Map 2 in Appendix C.
- Recommendation 5-1 contains a number of dwellings (see Photo 14) that appear particularly prone to flooding, due to their proximity to the creek and lower base elevations. There is also a bridge nearby, with its constriction on the floodway and potential for trapping debris. Consideration should be given to construction of temporary levee in this area to protect these vulnerable areas in the short-term. . Technical and material assistance for disaster preparedness may be feasible under other USACE authorities, and Clearwater County should discuss this topic directly with the District Readiness Office.
