Readiness Office

23 December 2015

SUBJECT: Technical Assistance Report concerning post-wildfire potential in Clearwater and Idaho Counties, Idaho

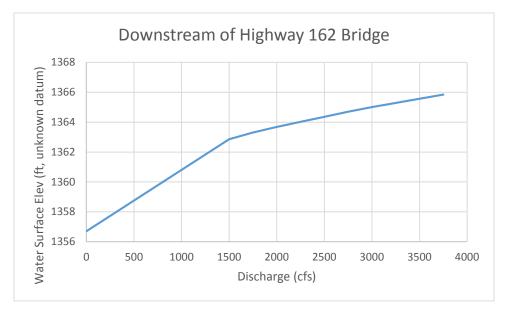
Figure 1. Discharge-elevation curve downstream of Highway 162 Bridge.

In an effort to assist emergency managers, a discharge-elevation curve (Figure 1) was prepared using the rudimentary HEC-RAS model. Incremental peak discharges are plotted for the model cross-section just downstream of the Highway 162 Bridge, to supplement the temporary Rapid Deployment Gage installed by the U.S. Geological Survey (USGS). It is worth noting a number of limitations are inherent in this rating curve; the modeling geometry, as noted previously, is quite old (~1998 or earlier), the elevation datum for the geometry is unknown (assumed to be NGVD 1929), no attempt was made to calibrate the model to contemporary data, and the bridge geometry in the model is apparently from an earlier bridge, with piers, that has since been replaced by a clear-span bridge deck (Photo 4). This rating curve may be of some value to alert county staff when flow levels approach potentially damaging levels. An accompanying table of notable overbank flows observed from the HEC-RAS model for the flow range is shown in Table 4, below. It is understood that a discharge-stage rating curve will not be developed by the USGS. It may be necessary to apply a shift to the elevation values based on observed past behavior, and as it is applied. It should also be noted that overbank flows may remain out of the channel for some distance down-valley, once they occur.

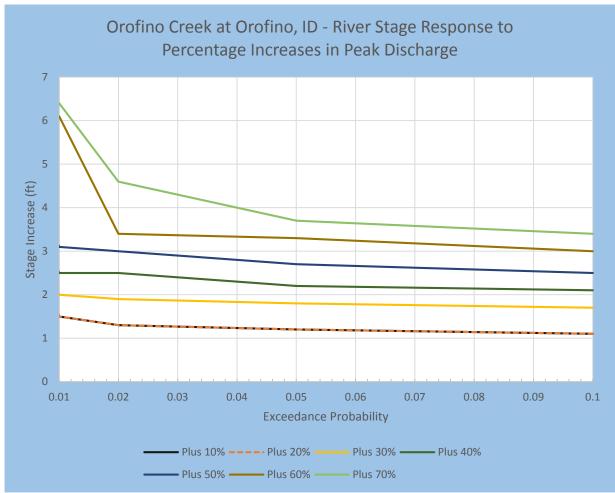
Figure 3. Increased Stage of Orofino Creek near Orofino, ID, vs. Percentage Increases in Exceedance Probability Peak Discharge.

(a) Runoff. In lieu of quantitative information on increases in peak discharge, an existing HEC-RAS model was modified to examine river stage sensitivity to percentage increases in exceedance probability peaks. The existing model included a reach of the lower Orofino Creek, from its confluence with the Clearwater River upstream about 2 miles, was used to generate curves of additional river stage for increased exceedance peaks at 10% increase intervals. A family of curves showing the potential increase in Orofino Creek's water surface elevation for the peak flow percentage increases is shown in Figure 3, below. This figure indicates that increases in peak runoff of only 10 percent result in increased river stages of more than a foot for the 10 percent through the 1 percent annual chance exceedance probability events. Similarly, a 40 percent increase in peaks increases stages by more than 2 feet for the same range of events, with stages increased by more than 3 feet for a 60 percent increase in event peaks.

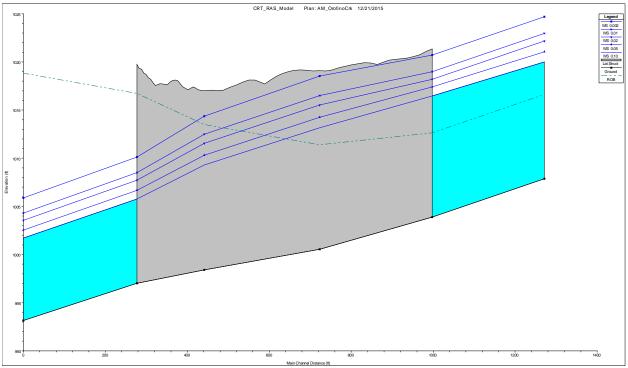
Figure 4. HEC-RAS profile plot, showing confining Lateral Structure (gray area) on right (north) bank of floodplain.

potential. The existing HEC-RAS mapping uses a *Lateral structure* to confine flows to the channel area until terrain features are overtopped, when excess flows spill into a series of ponding area to the north of the confined floodplain (see Figure 4). The three ponding areas represent the greater Orofino developed area, in general. The (pre-fire) frequency discharge profiles indicate near overtopping (and minimal freeboard) of this confining feature for larger events. This suggests that there may be sufficient economic benefits to justify construction of a levee to better protect the developed areas in Orofino from flood risks associated with Orofino Creek. The potential benefits of such a feature (or suitable alternative) should be considered as a longer-term strategy.
